ULT FREEZER BEST PRACTICE: IMPACTS
EPPENDORF F570H PERFORMANCE, UNIVERSITY OF BRISTOL

ANDY EVANS - GREEN LIGHT LABORATORIES LTD

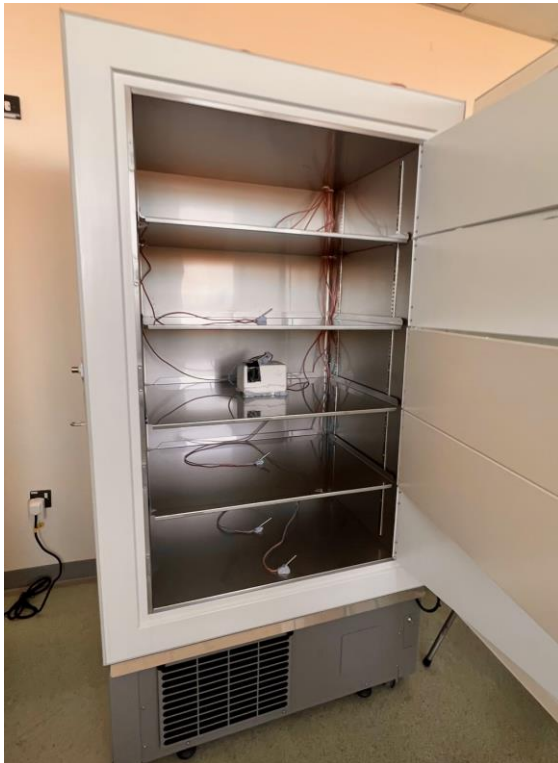
Figure 1. The F570h fitted with PT1000 probes and energy monitor.

Quantifying the impact of bad practice was carried out at the Learning and Research Centre, University of Bristol. The study was jointly commissioned by Scientific Laboratory Supplies Ltd (SLS) and Eppendorf UK. The ULT freezer tested was the Eppendorf F570h. The laboratory space used was air conditioned with an ambient of 23°C (+/-1.5°C). This case study used the Logical Wireless Monitoring system utilizing their energy monitors, temperature probes and online platform to record all the data. In each compartment a UKAS calibrated PT1000 probe was placed in the centrepoint of each shelf (figure 1).

Furthermore, additional probes were positioned at the back of the top compartment (compartment 1) and the front of the bottom compartment (compartment 5). The F570h was first tested without any poor usage/conditions. This first step in testing provided the baseline data by which the impacts of bad practice could be measured against.

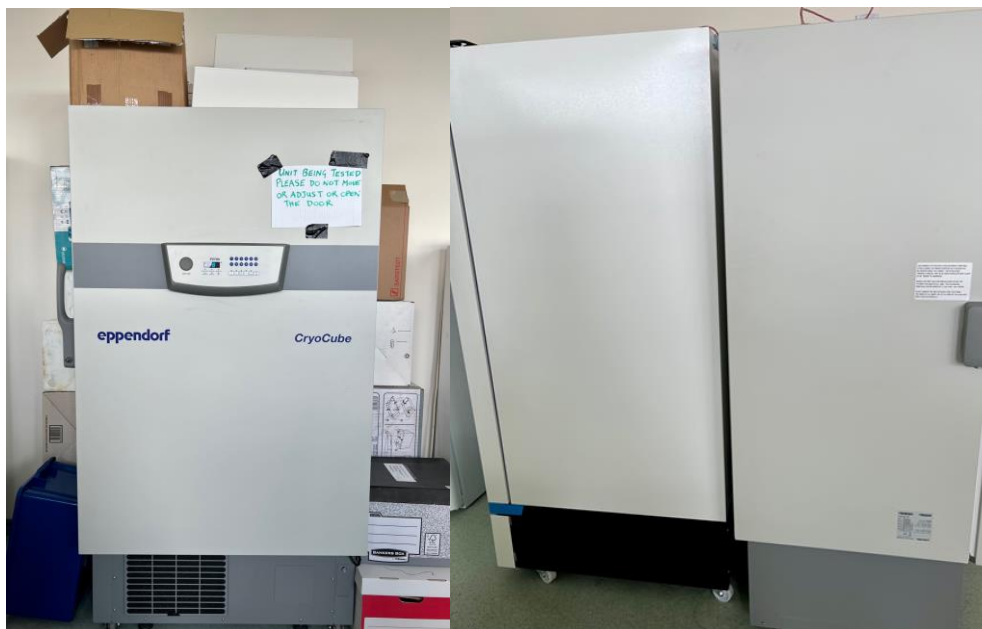
Figure 4. On the left, poor spacing. Placing a ULT freezer back to back with another is another form of poor spacing was examined separately.

Keeping a distance of $\geq 50\text{cm}$ at the sides and rear of the ULT freezer is another action an end user can take. Doing so provides the space for airflow, allowing the warm air ejected at the rear of the unit to rise and dissipate. To simulate poor spacing the rear of the ULT freezer was pushed flat against the wall with boxes and containers placed on top and on both sides of the freezer (figure 4).

Akin to poor spacing, placing the ULT freezer away from other heat sources allows for the efficient cooling of the refrigeration system. One example of what steps not to take is placing two ULT freezers back to back (figure 4).

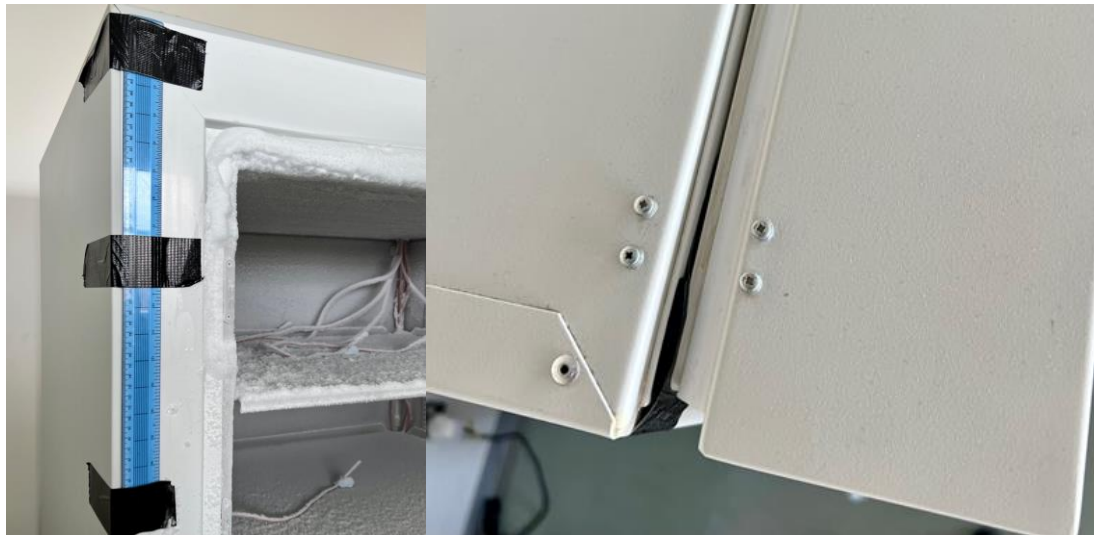
Figure 5. Left; securing the 45cm long ruler to the top left-hand side of the opened freezer created at 3.8mm gap (right) between the door seal and the freezer chamber. The obstructed seal spanned the entire height of the top freezer compartment (1) and ~50% of that of compartment 2.

Keeping the door seal clean, unobstructed and intact helps to keep the ULT freezer chamber at the desired set temperature and reduces the build up of ice. The action taken to obstruct the door seal is shown in figure 5.

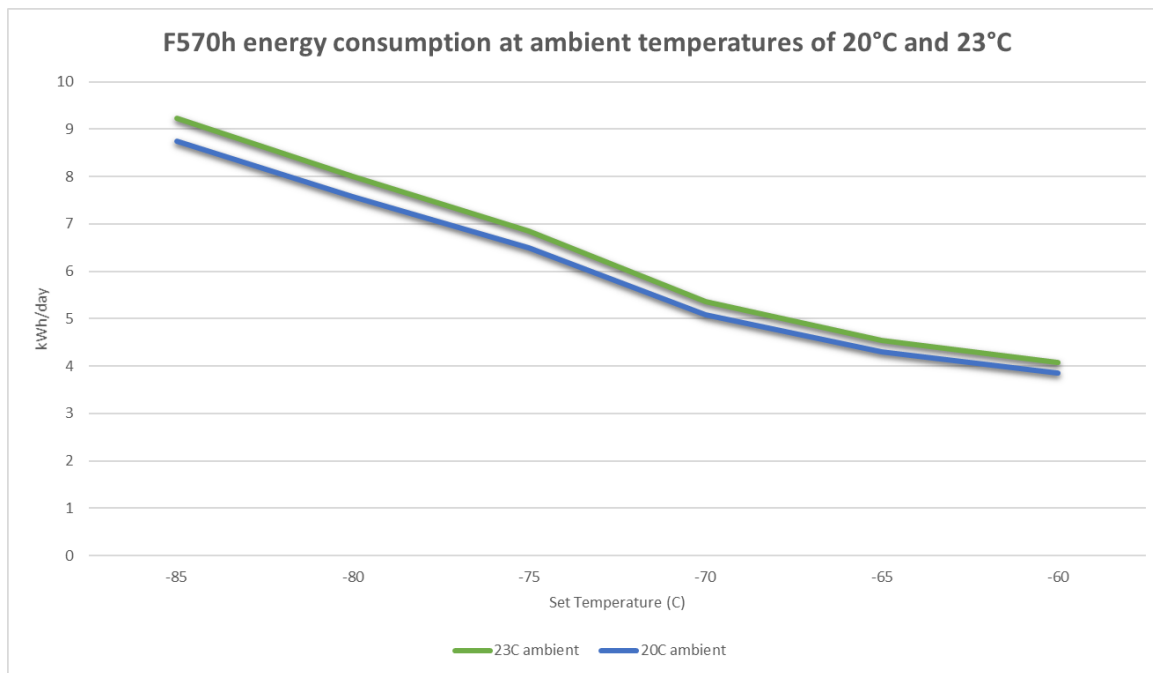
Figure 11. F570h energy consumption at different ambient temperatures. On average, placing the ULT freezer in the 20C

During the case study the F570h was also tested in a colder freezer room. The temperature in the freezer room was measured as 20°C(+/-1°C). The impact of ambient temperature upon energy consumption is shown in figure 11.

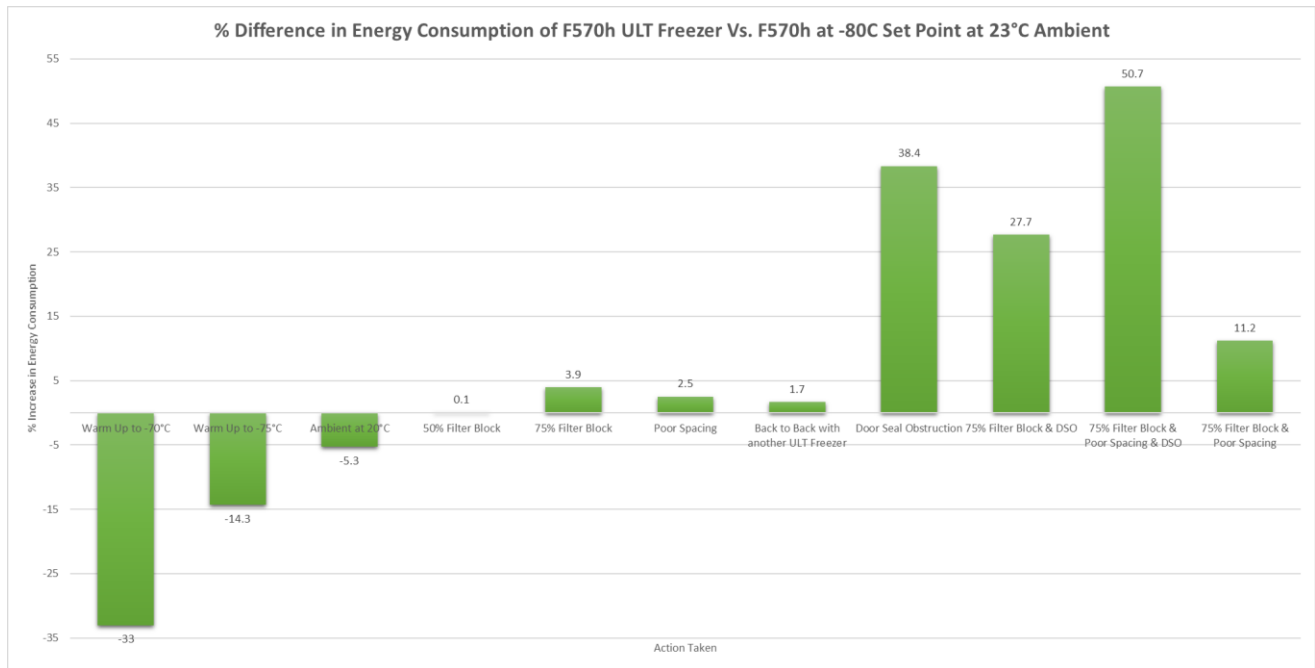
Figure 13. Impacts of actions and bad practice upon ULT freezer energy consumption.

With energy conservation being a vital step towards sustainable lab operations. The testing has shown that raising the set temperature of the ULT freezer and lowering the ambient temperatures do confer much needed energy savings. However, the impacts of bad practice must be conveyed to end users so that their impacts may be avoided (figure 13).

The presence of bad practice in ULT freezer usage may easily eliminate and outweigh the energy savings gained by warming up the freezer set temperature and/or placing the unit in a cooler environment.
